Nissens Technical Tips

CLIMATE SYSTEM

NISSENS' ADVICE: CHECK THE RADIATOR WHEN SERVICING THE A/C SYSTEM

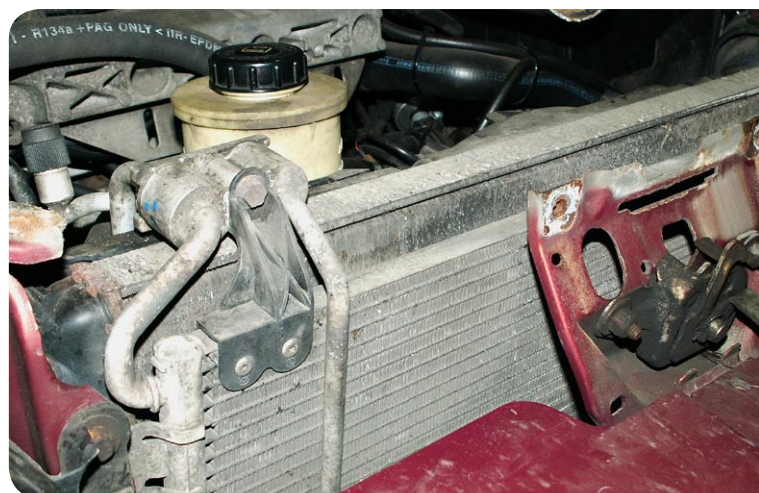
Photo 1

A good example is a Renault Scenic 2002, with gasoline engine 1.6i, which was handed over to a professional garage specialized in cooling systems, due to a problem with a perforated condenser. Disassembling the condenser in this car is no problem: you only have to unscrew the front bumper parts to uncover the cooling set (photo 1). Then the A/C connection and four bolts are dismantled, and we take out the condenser (photo 2).

replacing the condenser, the customer may have another problem after some time. After assembly of the condenser, the access to the radiator is closed (photo 1), so another disassembly of the condenser would mean additional expenses (work and gases). When examining the radiator, the mechanic must check the condition of other connected parts, such as connections, flexible hoses, tubes etc. It is a good idea to ask the user for how long the A/C system has not been working.

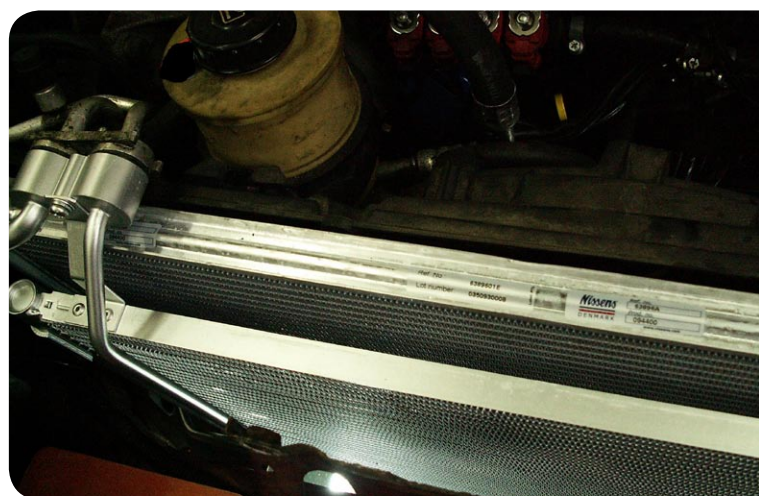
Photo 4

If the problem has existed for a long time and the system has thus been open to the ambient air, the dryer must be replaced. After examining parts and circuits, we mount a new radiator (Nissens' ref. 63896A), and a new condenser (Nissens' ref. 94572 – photo 4).
