Nissens Technical Tips

CLIMATE SYSTEM

REGULAR INSPECTION OF A/C CIRCUIT – HIGHLY IMPORTANT!

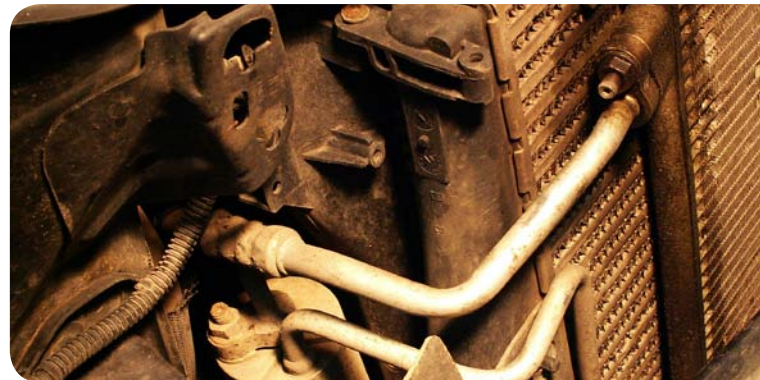
Photo 1

An examination of the circuit revealed a huge leakage at condenser connections (photo 1). The condenser itself also showed some leakages on the surface, but they were the result of mechanical damage to the car due to a small collision in the past (photo 2).

It was decided to install a new condenser, Nissens 94805, which is originally equipped with dryer (photos 3 and 4). At the same time, new O-rings, strengthened with steel, were installed. The compressor was filled with new oil.
